## Case Study

**Project:** Deep water ROV Inspection on pipeline with internal degradation

**Problem:** Assessment of a deepwater pipeline identified a reasonably high likelihood of internal degradation. The operator determined that inspection was necessary to establish the depths and characteristics of any degradation present. Inspection using ILI techniques was not possible due to the configuration of the pipeline, hence an external inspection solution was required. The pipeline was at a depth of 500 m, this precluded the use of divers and an ROV deployed inspection solution was required.

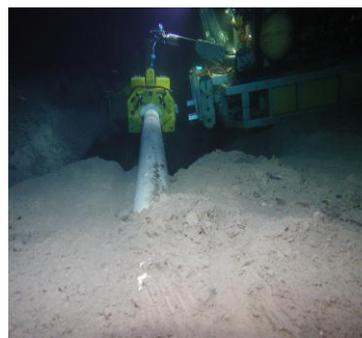
**Figure 1: ROV-iT at 500 m depth conducting ToFD and Corrosion Mapping**

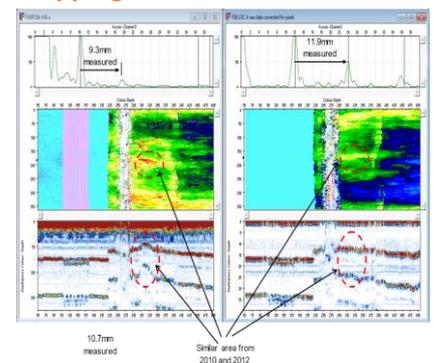
The inspection provided detailed information to enable an integrity assessment to be performed, this demonstrated that the pipeline remains fit for service.

**Figure 3: Example of corrosion mapping results**
