Case Study

Project: TOFD for sizing remaining wall under External Blisters prior to Fabric Maintenance

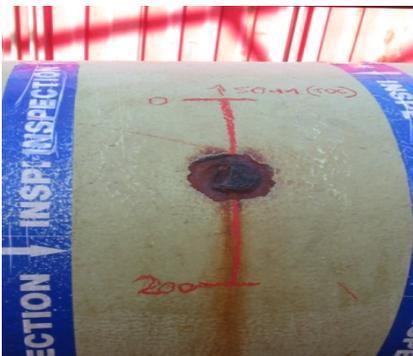
External blisters were identified during a visual inspection of process pipe work on board a North Sea platform. Fabric maintenance is required to rectify these defects, however, until the thickness of remaining steel under blisters is confirmed, there is a potential that any remedial work to the external surface could cause leakage or failure of the pipe section.

Figure 1
Photograph of visually identified external blister

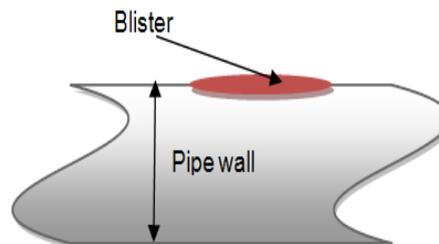
Figure 2
External blister of unknown depth.

A test sample was manufactured with machined defects of 1 mm, 2 mm and 3 mm to simulate external defects, these were sized to an extremely small tolerance. Further investigation was made into sizing larger defects with a ligament of 5 mm, 10 mm and 15 mm. These were also found and sized using the same technique, This technique has now been used effectively in the field (See Figures 2 & 3).

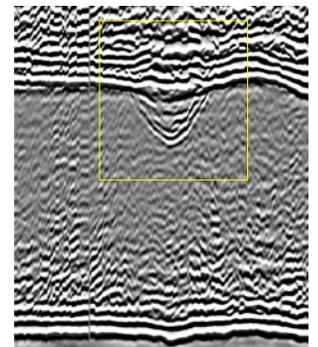
Figure 3
TOFD Image of blister on pipe work
