Case Study

Project: Fitness For Service (FFS) on a 16" Main Oil Line

Problem: Failure of an additive injection quill had resulted in accelerated corrosion downstream of the injection point on a 16" Main Oil Line. Sonomatic were retained in order to ascertain if the line was fit for continued operation in the degraded condition.

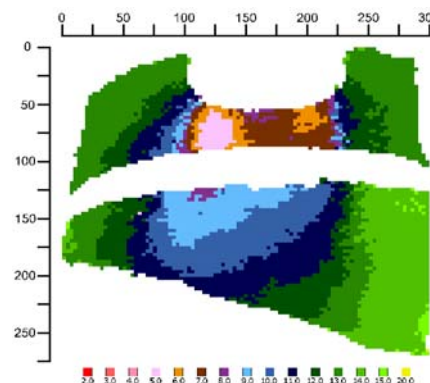
Figure 2:

Corrosion mapping was conducted on the affected region in order to establish the extent of the defect (Figure 2). Time of flight diffraction (TOFD) was then carried out on the welds in order to establish that preferential weld erosion was not evident (Figure 3) and to confirm the minimum thickness.

The measurements were then used in conjunction with operating and design parameters to conduct a fitness for service according to API 579.
