## Case Study

**Project:** Subsea Manifold Integrity Assessment

**Scope:** Subsea inspection of welds and statistical analysis to estimate worst condition.

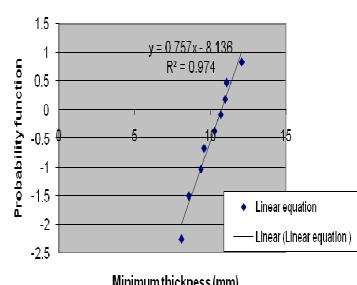
**Figure 2:**

The potential for preferential weld corrosion in a manifold had been identified by the operator and a decision was made to carry out a subsea TOFD inspection. Sonomatic provided the subsea inspection and TOFD was successfully carried out on most of the welds and identified significant levels of corrosion. There were a number of welds where access for inspection was not possible. Since these welds were subject to similar operating conditions to those inspected it was possible to use the data obtained in a statistical analysis to estimate the expected minimum thickness and the probability of an unacceptable condition being present.

Sonomatic determined that the results of the TOFD inspection were suitable for use in an Extreme Value Analysis (EVA). This indicated that the expected minimum thickness for the system would be low and the probability of a leakage condition was approaching unacceptable levels. Replacement was therefore recommended.

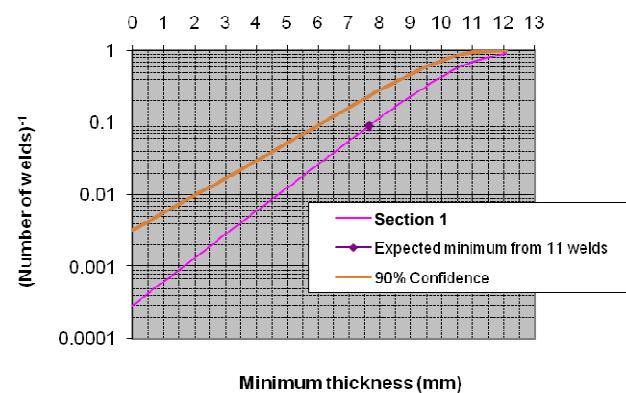
**Figure 3:**

The Sonomatic subsea TOFD provided accurate results for use in the EVA. The analysis carried out showed that there was a high probability that the remaining thickness in the welds that could not be inspected would be considerably less than the minimum measured in the welds inspected. This provided a strong case to the operator showing that the probability of leakage was approaching unacceptable levels. The integrity team was able to use this to support a case for replacement of part of the manifold.

The work carried out ensured appropriate action was taken to prevent a leak (areas of very low wall thickness were found in some of the welds on removal from service). The integrity management team were able to justify the Capex needed on the basis of the strong technical case made.
