Case Study

Project: Civa modelling of the inspection of a nozzle to domed end weld on a production separator.

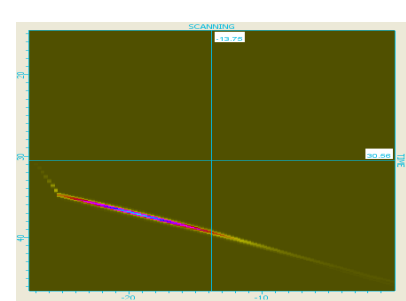
Figure 3:

Flaws were placed at several locations within the nozzle weld and results were simulated using a selection of shear wave angled probes (Figure 3 shows the results from a single scan).

The results were used to determine an inspection strategy that would provide the greatest probability of detection for the flaws under consideration.
