## Case Study

**Project:** Non-intrusive inspection utilising Time of Flight Diffraction (TOFD) Screening, TOFD on welds, video tracked corrosion mapping, and Multiskip techniques on LP Separator as alternative to internal visual inspection in order to reduce shutdown requirements.

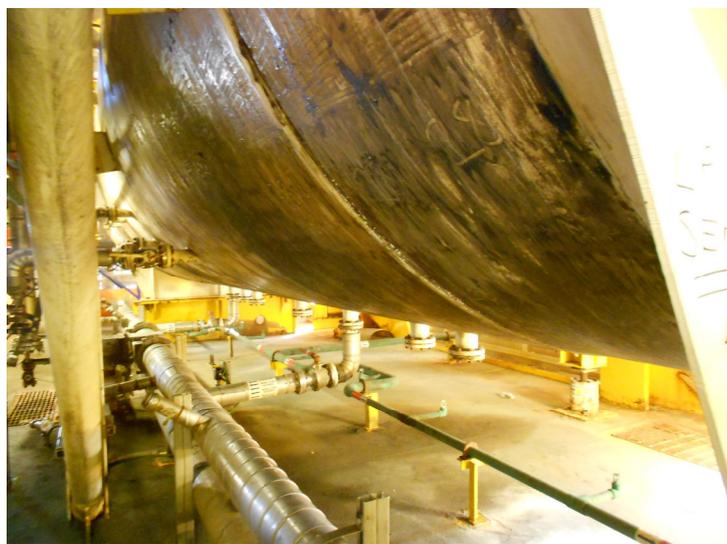
**Figure 1: LP Separator**

An IVI was due to be carried out on an LP Separator during a platform shutdown (Figure 1). In order to reduce shutdown times, the vessel was assessed as being suitable for NII and several ultrasonic based techniques were chosen to inspect the regions of the vessel most susceptible to corrosion. Sonomatic carried out the NII inspection and the analysis of the results.

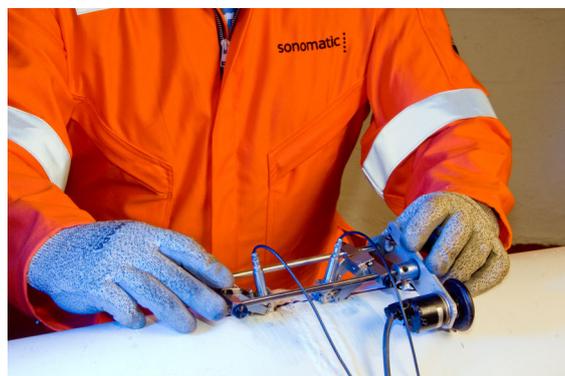
**Figure 2: TOFD technique**

**Solution:** TOFD Screening was used as the main technique, providing a rapid, high coverage inspection of the vessel shell and ends (Figure 2). This was supported by video tracked corrosion mapping for regions inaccessible for TOFD and Multiskip scanning for regions inaccessible due to supports.

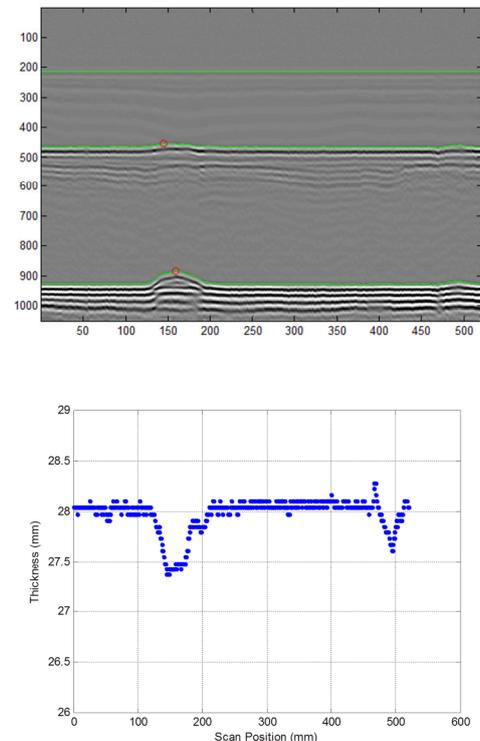
**Figure 3: TOFD analysis**

The TOFD data was processed using Sonomatic's bespoke TOFD screening software which straightens data and finds lateral, compression and mode arrival times automatically (Figure 3, top). Over 3000 files were analysed and used to produce thickness profiles (Figure 3, bottom) which were then used to generate corrosion maps (Figure 4) allowing visual interpretation of the data. Statistical analysis was also performed on the data to determine if corrosion was present.

The probability of detection (POD) was found to be high for the inspection. Using the results of the inspection and evaluation, the Operator was able to make the case that the NII was a full replacement for IVI and was able to exclude the vessel from the planned shutdown work scope reducing the shut down by 10 days.
