## Case Study

**Project:** Civa modelling for assessment of the effectiveness of the inspection procedures applied to complex geometry welds in a high pressure pipework system.

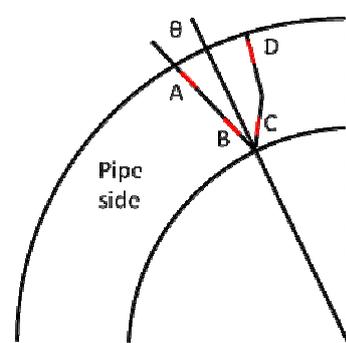
Figure 2:

Flaws with different orientations were created within the weld (as shown schematically in Figure 2) and results were simulated using shear wave inspection as per the procedures proposed, (Figure 3 shows the results from a single scan).
